# Case Study

## Trihalomethane Removal Systems

### Rockville, MD

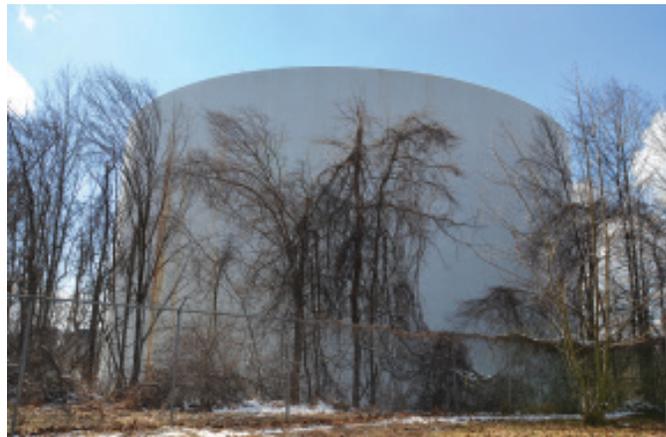
Figure 1. The 8 MG Hunting Hill tank has a high water volume and low turnover, which results in high water age and elevated THM levels

Rockville's managers created an internal water quality team that met once a month to analyze water quality data and explore ways to lower TTHM levels in the distribution system. Engineers from the firm Hazen and Sawyer also provided valuable help with the analysis. The analysis of Rockville's water distribution system revealed a significant weakness that was contributing to high TTHM levels: the 8 MG Hunting Hill tank (Figure 1).

The Hunting Hill storage tank was constructed in 1969 as an oversized steel reservoir located at ground level. The tank is approximately 96-feet in height and 135-feet in diameter and requires a high water level to provide sufficient water pressure. With a low average daily turnover of only 0.65 MGD, or about 8%, average detention time in this tank can exceed 10 days and result in high water age. THMs continue to form with time, so high water age creates higher levels of THMs (TTHM levels above 140 ppb have been measured at this tank). The City of Rockville considered a range of options for reducing water age, including tearing down the tank and building an elevated tank with less capacity and better turnover in its place.

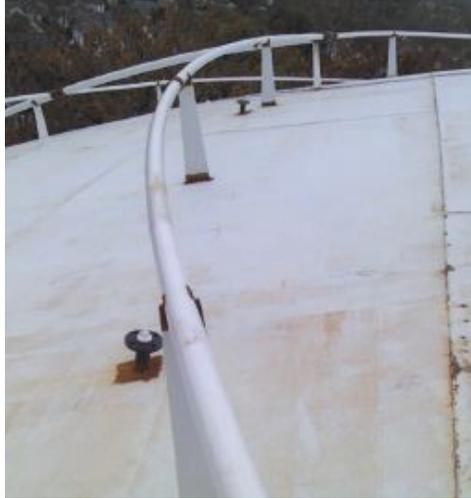
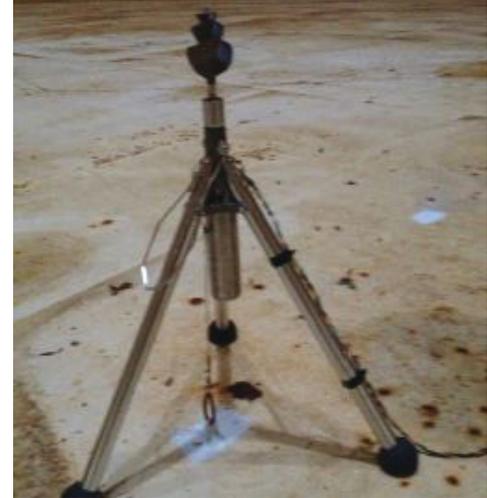
Figure 2a, b. Components of the TRS include a network of header pipes and spray nozzles installed on the roof of the tank and the PAX Water Mixer installed on the floor of the tank.

SUEZ Advanced Solutions and PAX Water Technologies proposed their Trihalomethane Removal System (TRS) to meet the requirements of the project. TRS is a custom design-build, in-tank aeration system that utilizes mixing and aeration together to maximize THM removal. Unlike more traditional approaches that require utilities or engineers to source aeration hardware and develop their own scaling relationships and installation design, TRS utilizes a proprietary design process (the NEPTUNE Toolbox) that ensures that each aeration system is optimized for energy efficiency and installed in a manner that ensures reliable performance for the life of the tank.

SUEZ Advanced Solutions and their subcontractor, PAX Water, were awarded the contract and work began in the summer of 2012 (Figure 2a,b). Construction and installation of the system was complicated by the large size of the tank, the numerous spray nozzles installed, and the inevitable complexities and delays that occur with any large infrastructure upgrade. By July 2013, the system was up and running and validation testing had begun.

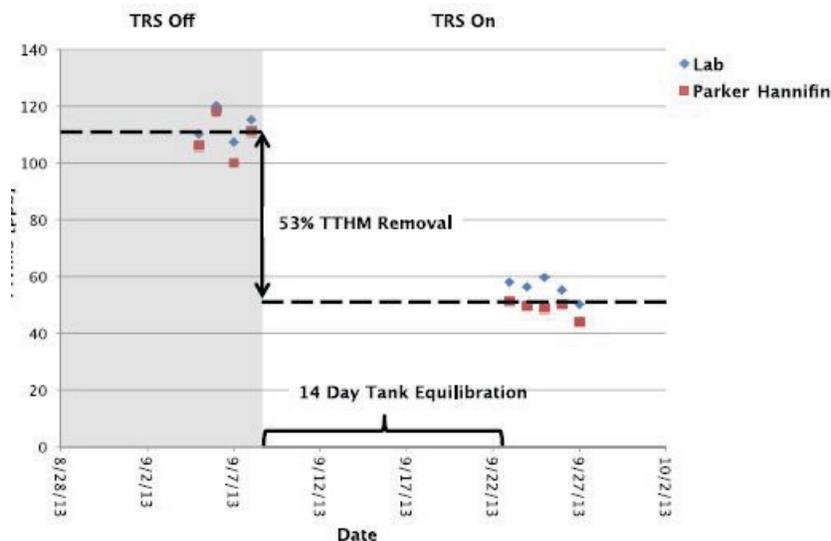
Figure 3. TTHM levels in water leaving the Hunting Hill tank with the TRS off (shaded in gray) compared with THM levels with the TRS on. After the TRS is turned on, time is required for the TTHM levels to reach a steady-state level of reduction – in this case 14 days.

The final validation measurements were taken in September 2013. The City of Rockville performed split THM measurements using both the Parker Hannifin analyzer and a contract laboratory (that used an EPA-approved method). The results showed that the TRS removed an average of 53% of the THMs in the tank (Figure 3). The results from the Parker Hannifin analyzer closely tracked those from the contract lab, but were slightly lower in absolute value. The TRS has remained in operation ever since.
