CASE STUDY

TRIHALOMETHANE REMOVAL SYSTEMS

SAN JOSE WATER, CA

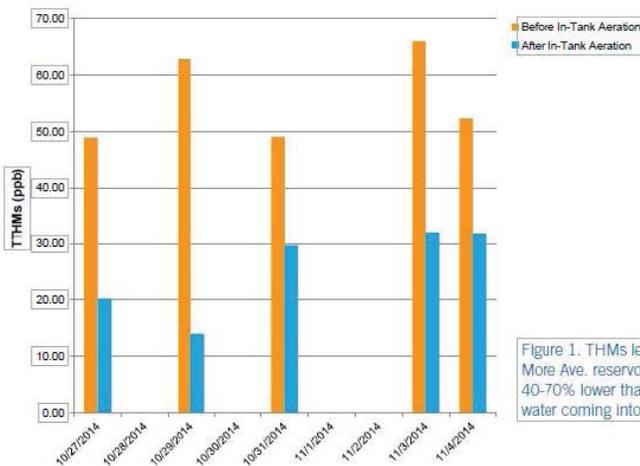
Figure 1. THMs leaving the More Ave. reservoir were 40-70% lower than the water coming into the tank.

"We are seeing THM levels 40-70% lower leaving More Ave. reservoir than those coming in. We are very happy so far. We are seeing excellent results from the system, and noise has not been a problem."
