Case Study

Chemical Cleaning of Pressure Filters

Mendota, CA

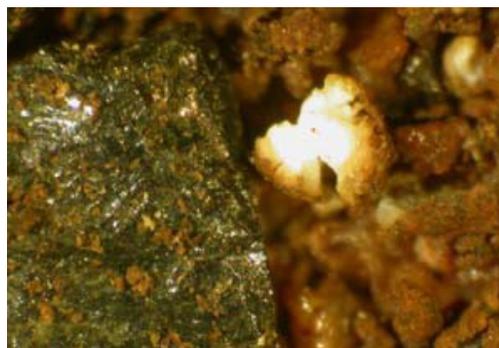
Visual inspection of filters at the Mendota Water Treatment Plant indicated heavy mineral accumulations on the media surface resembling iron and/or manganese. Extreme hydrogen sulfide odors were also detected in multiple filters, indicating a strong biological population. WTP (Water Treatment Plant) operators were unable to use the filters prior to cleaning due to the advanced fouling present within the system (increased turbidity and ineffective backwash cycles).

Media before chemical cleaning

Cleaning procedures called for reducing water levels within the units to 4-6 inches above the media surface, followed by introduction of the biodispersant, followed by application of phosphoric acid. The system size required 55 gallons of phosphoric acid and 28 gallons of biodispersant per filter.

All four filters were isolated, depressurized, opened, and visually inspected. Water levels were lowered to begin the cleaning process. The required quantities of chemicals were blended into a single cleaning solution and pumped into each filter vessel. Proper safety precautions were used for the mixing and application of these chemicals, which were applied to each filter unit with transfer pumps and allowed up to 19 hours of contact time. The cleaning solution was thoroughly mixed throughout the filter via air lancing. Regular agitation and mixing was conducted during the required contact time.

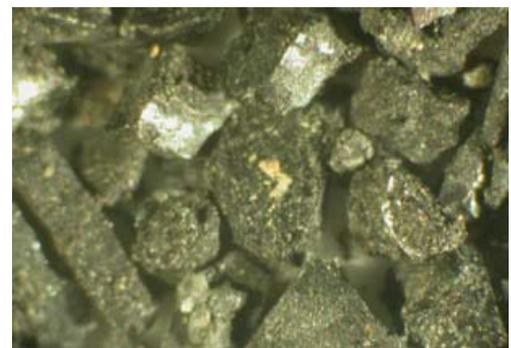
Post-cleaning inspection showed excellent removal of unwanted mineral and biological deposits on the media surface. Testing of filter effluent also recorded low turbidity levels. The customer was very pleased with the results of the cleaning process that allowed their WTP to return to normal treatment capacity and capabilities.

Media after chemical cleaning
